# Evaluation of Metal Containers for Shipping Hazardous Materials

(U.S.) Naval Air Development Center, Warminster, PA

Department of Transportation, Wishington, D. Office of Hazardous Majorials

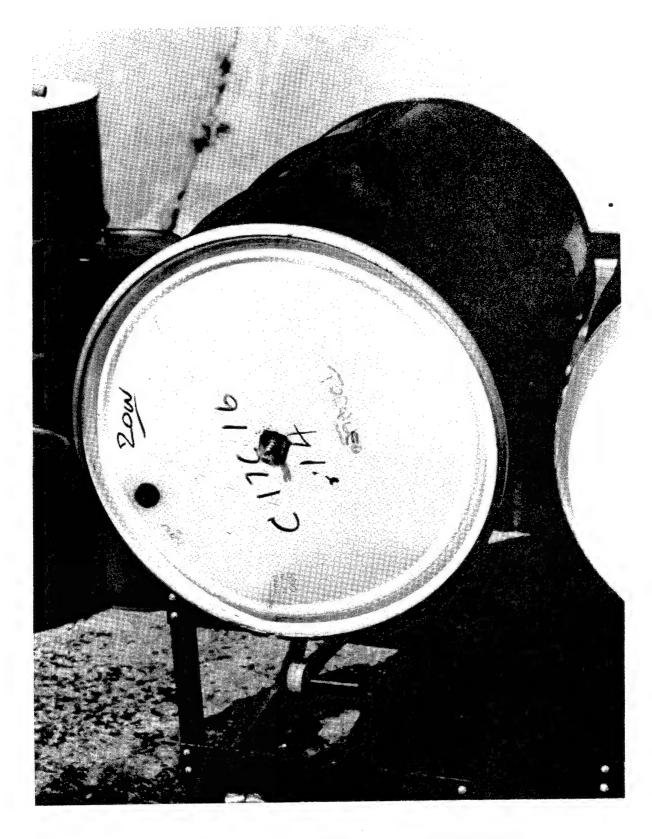
FIGURE

HYDROSTATIC PRESSURE TEST

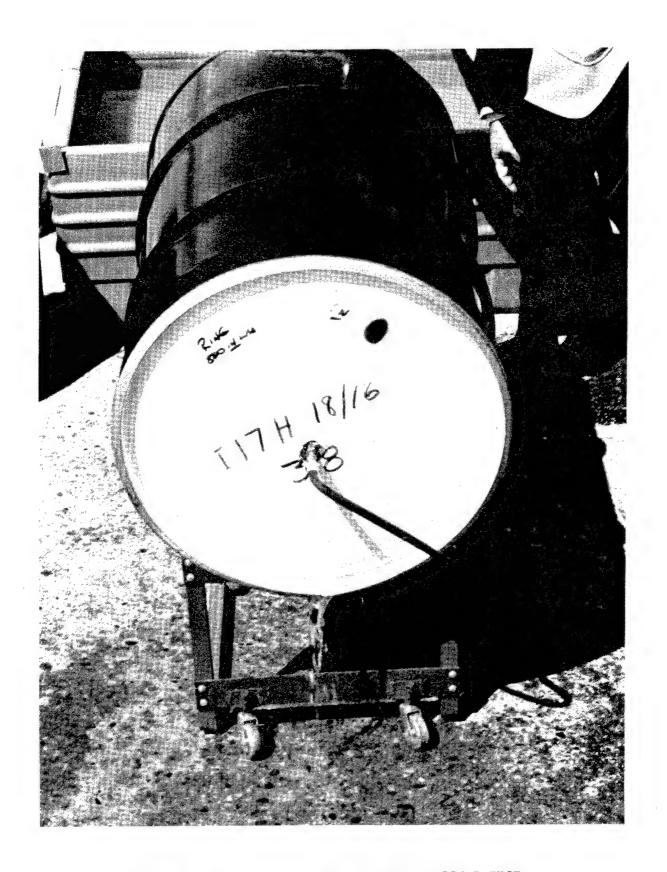
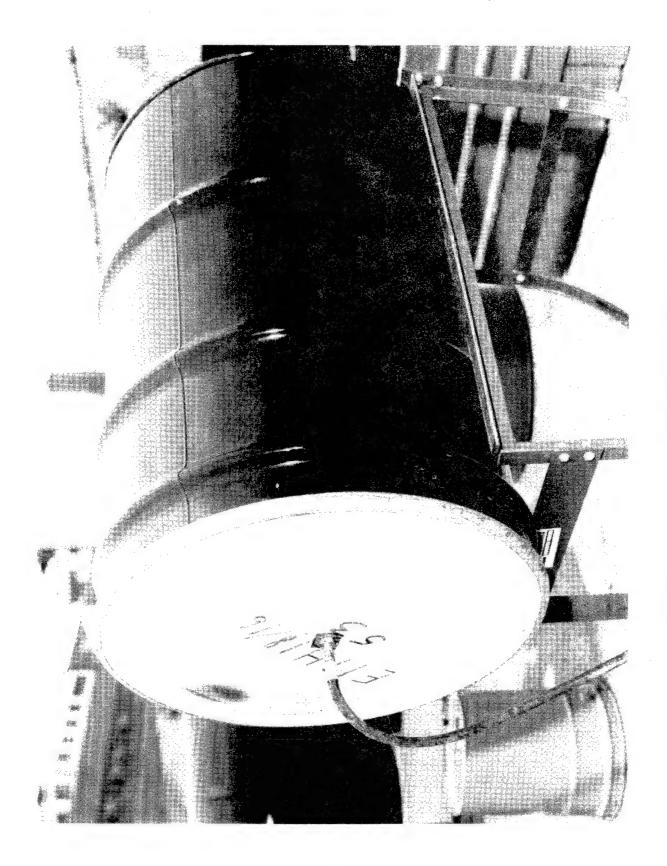
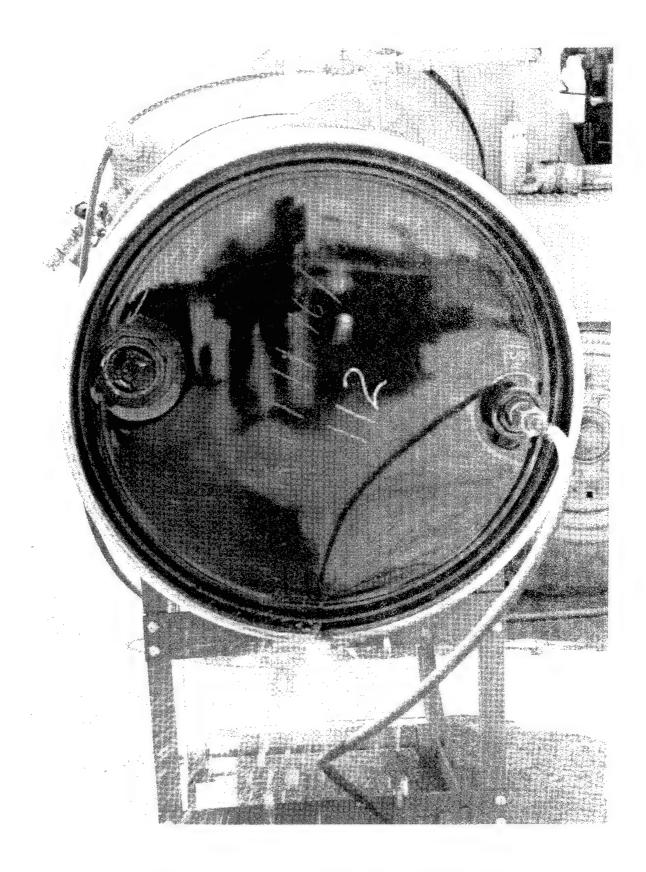
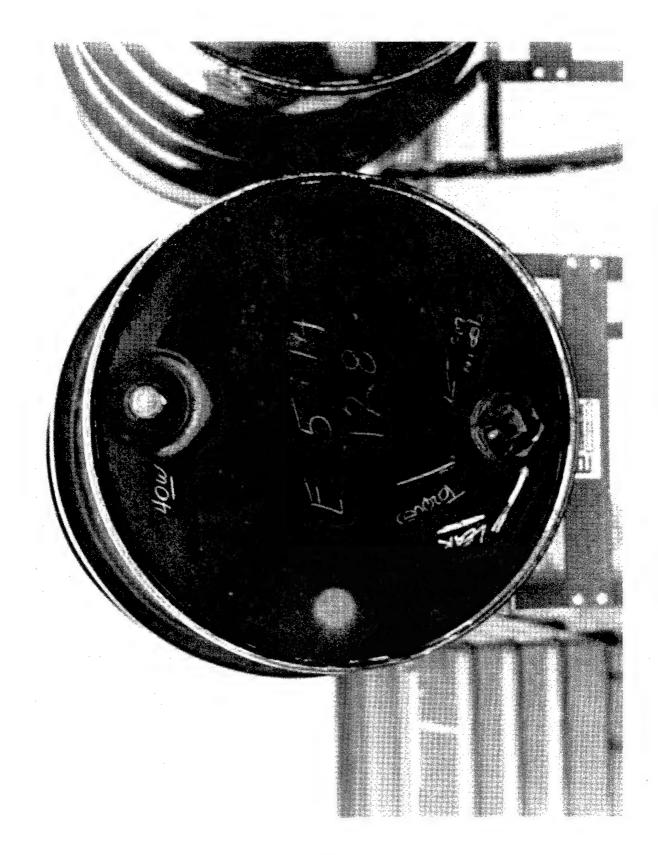
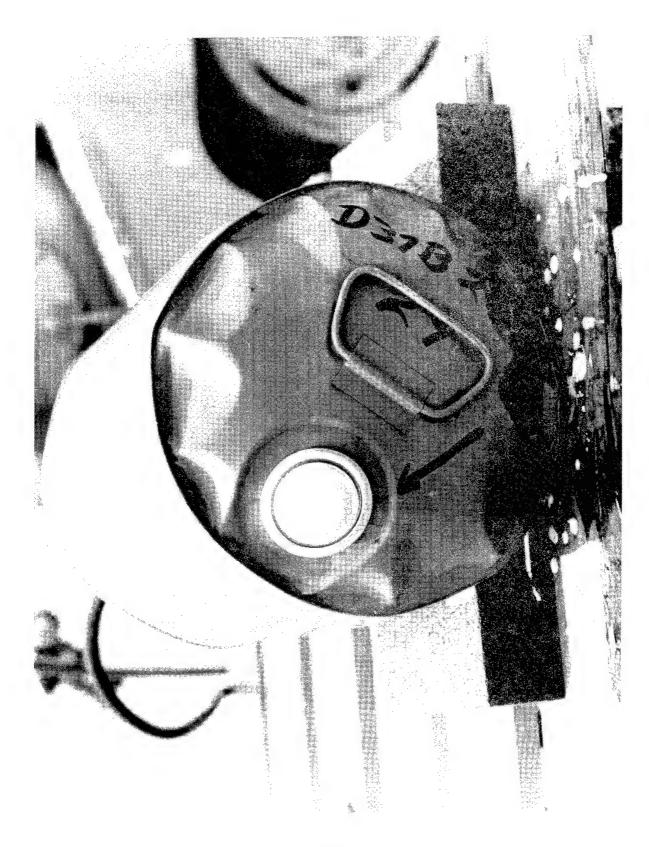
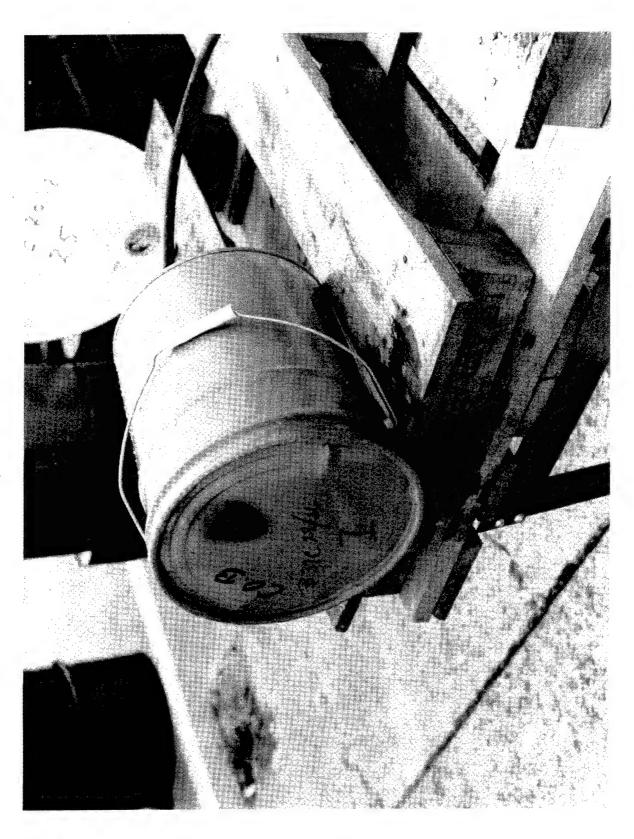
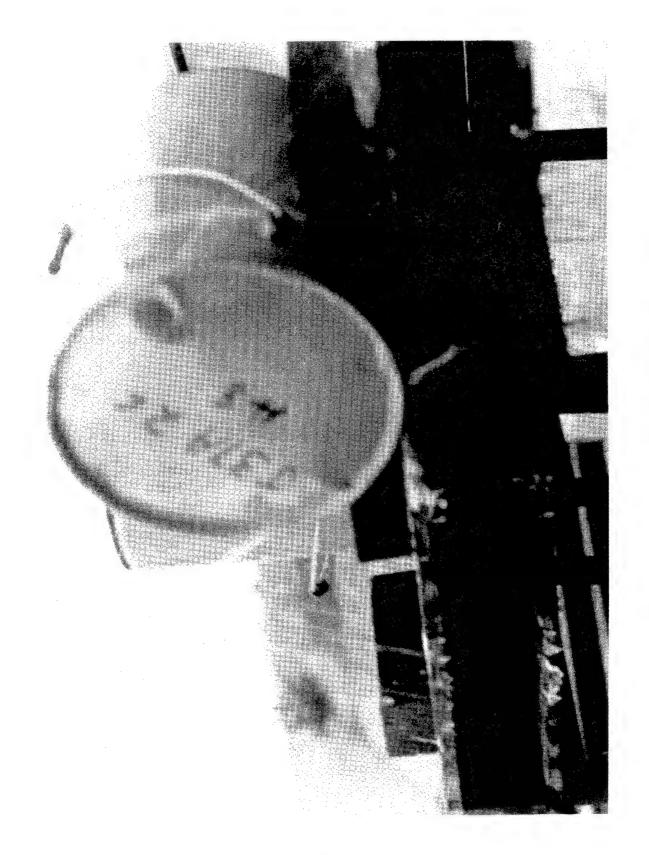
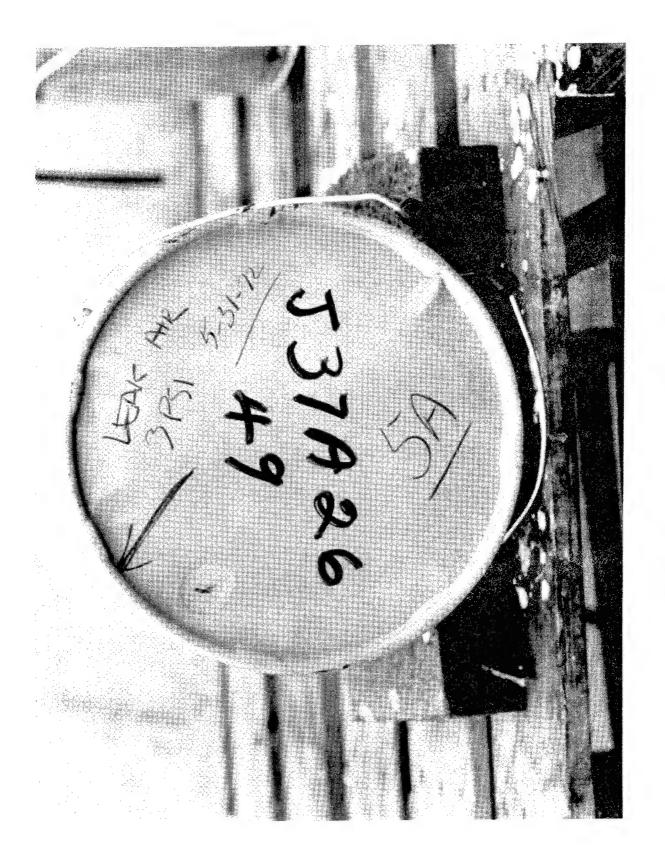
The test prosures were maintained for 5 minutes or until college read noted, indicating a leak. The results reported in Table 4 reveal that eight drums and seven pails failed the test. The drum failure: 6 noted as leaks at the locking ring joint for Exhibits 14, 38, 53, 57, 58, 92, 112, 113, and a leak at the 2 inch bung adaptor for 30110 128.

The pail far lures were noted as a leak at the flex spout for Exhibit 29, a leak at the upper chime for Exhibit 36, and a leak at the cover for Exhibits 7, 48, and 73. The failures are illustrated in Figure 4 through Figure 11.

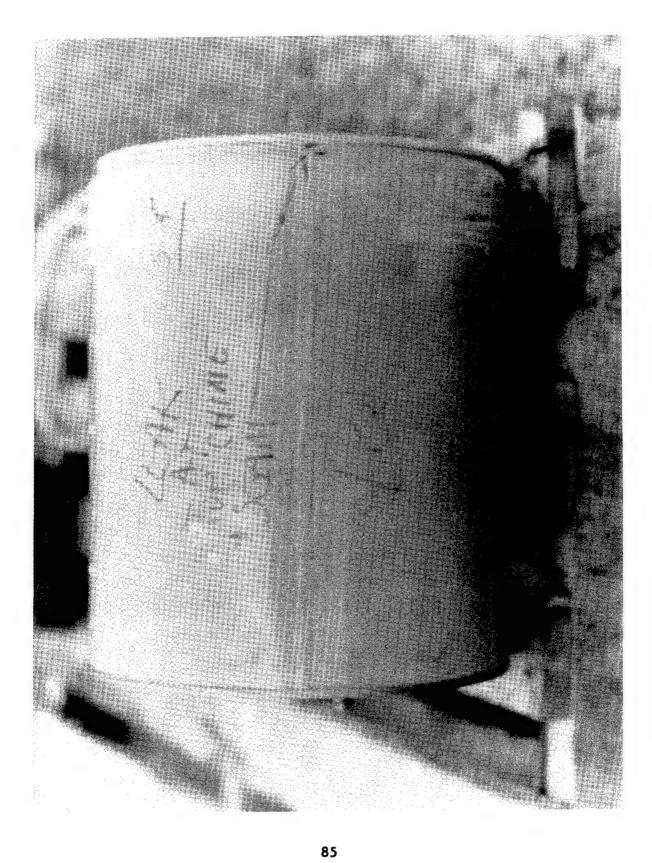
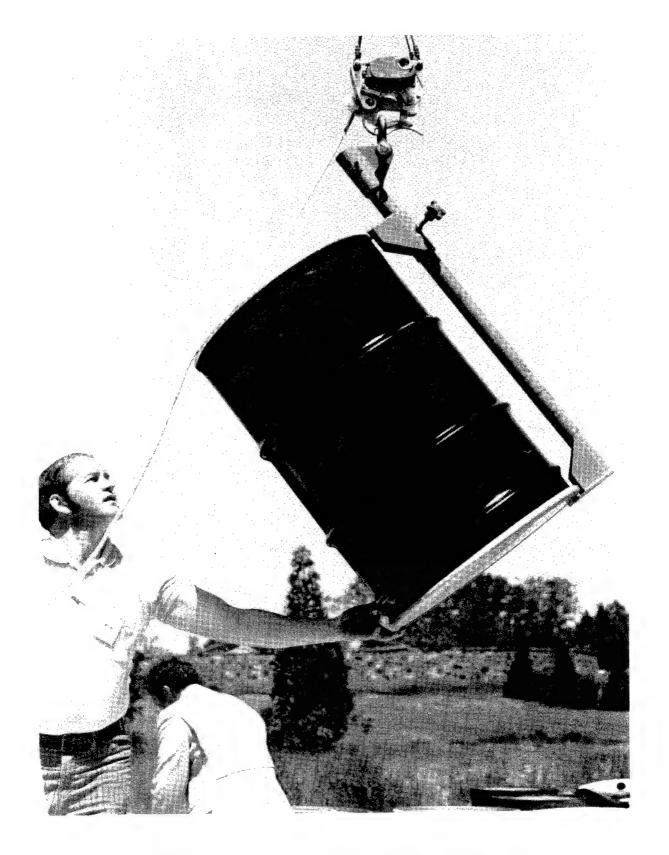
The prescured were maintained for 5 minutes or unless a leak was noted by a drop in the pressure gauge. After reaching the required pressure, a bubble supporting solution was applied to the seams, upper and lower chimes, and fittings. The containers were examined for evidence of leakage. The results reported in Table 4 reveal that no drums failed the test; because, five pails failed the test. The failures and noted as leaks at the lids for Exhibits 9, 10, 49, and 76. Exhibit 55 leaked at the intersection of the side seam and top chime. The type of failures are illustrated in Figures 12 and 13.

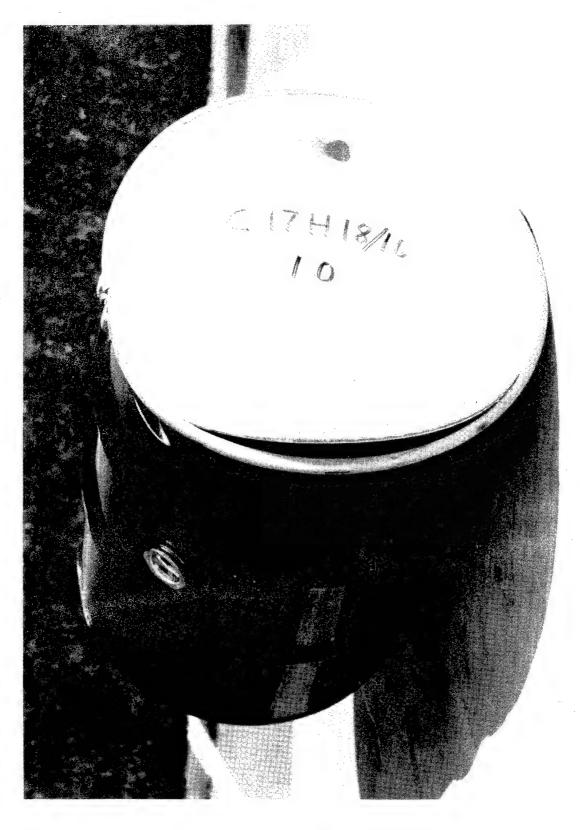
FIGURE 14

The containers were lifted using the drum lifter and positiound so that the head of the container faced downward and formed a diagonal with the impact surface as illustrated in Figure 14.

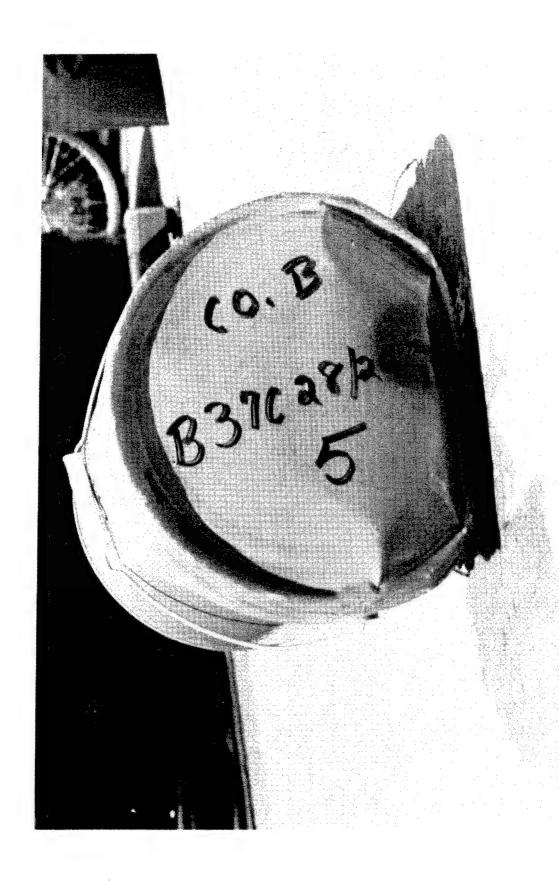
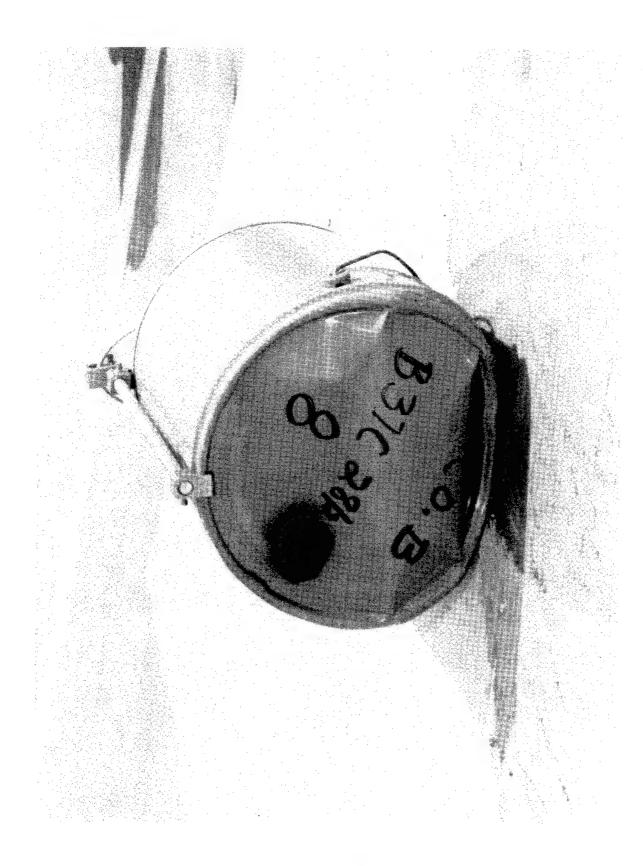
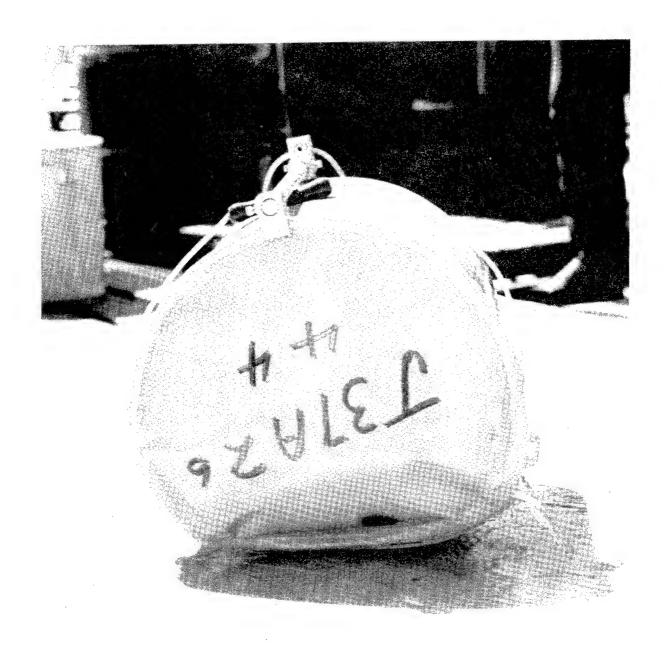
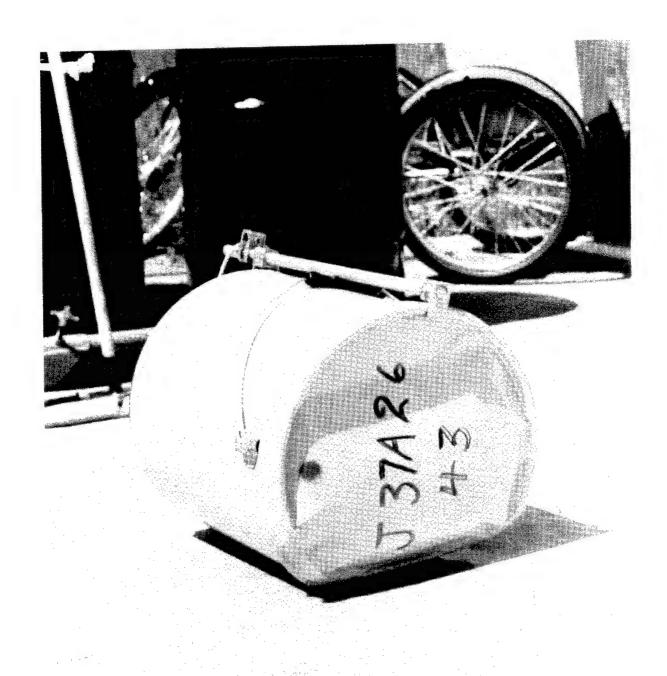
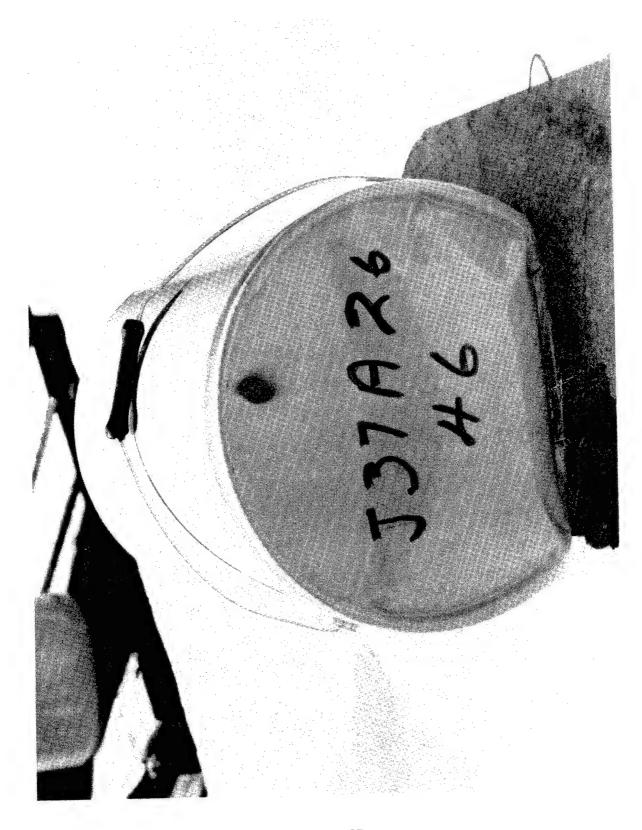
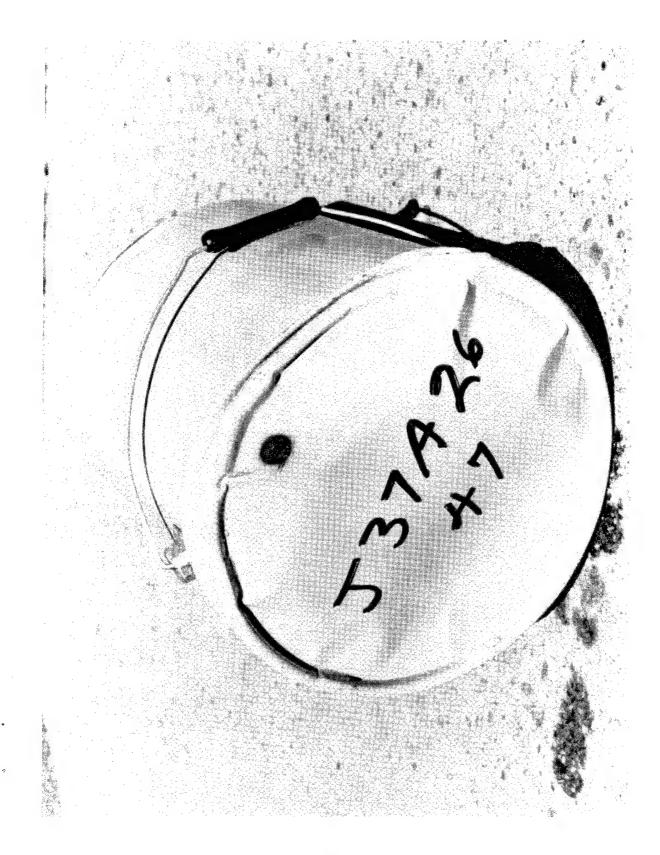
Hibbits 10, 16, 50, 54, 68, 141, and leaks at the local ring joint for Exhibits 132 and 140. The latter drums (132 and 140) were not tested, the leaks having occurred when they were lifted for testing. The failures are illustrated in Figures 15 through 19. Pail failures were noted as a leak at the flex spout of Exhibit 37, severe leaks in the impact area for Exhibits 5, 6, 8, and 57 when dropped from 32 inches, and a slight leak for Exhibit 67 when dropped from 28 inches. Exhibits 41 and 44 leaked after a 4-foot drop, Exhibit 43 leaked after a 42-foot drop, end Exhibits 46 and 47 leaked after a 36-inch drop. Typical failures are illustrated in Figures 20 through 26.

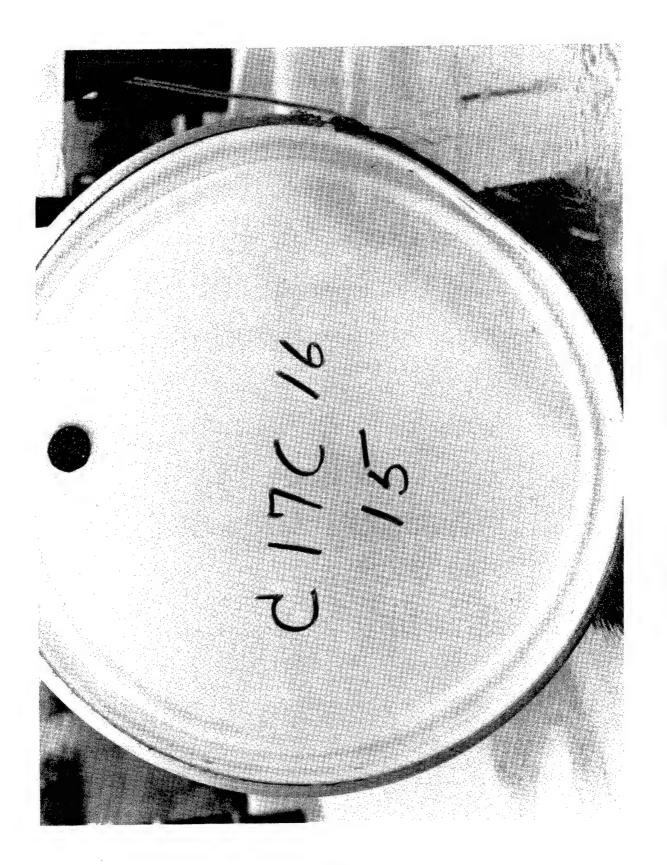
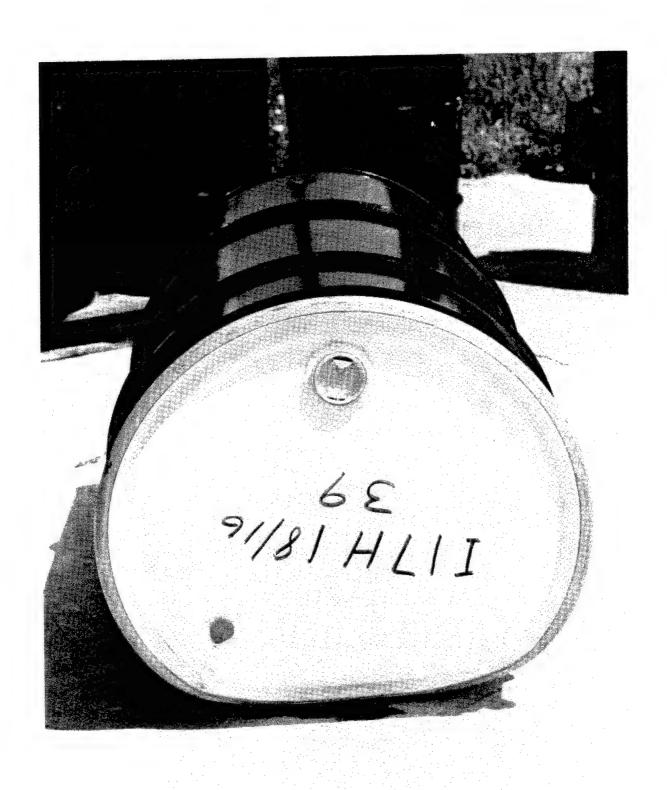
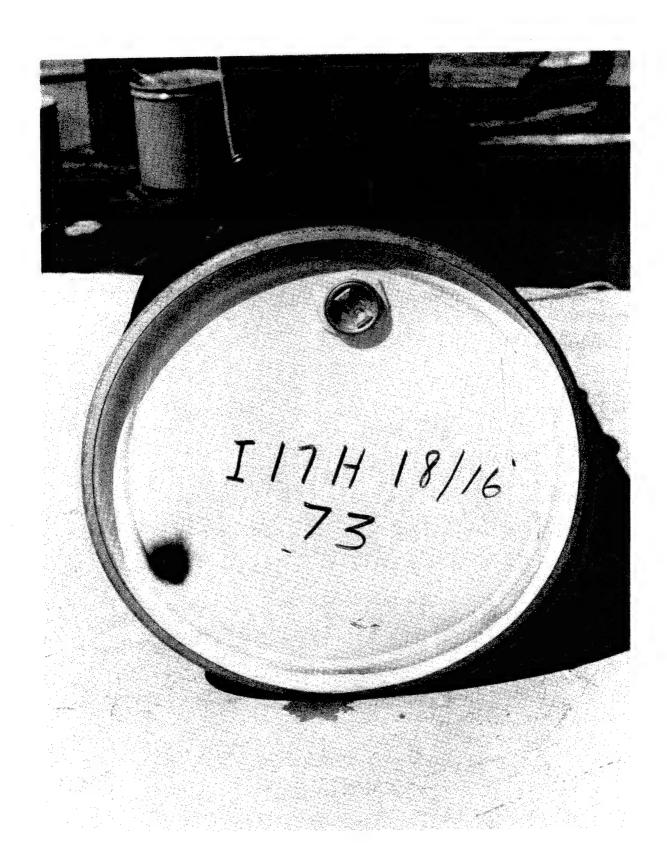
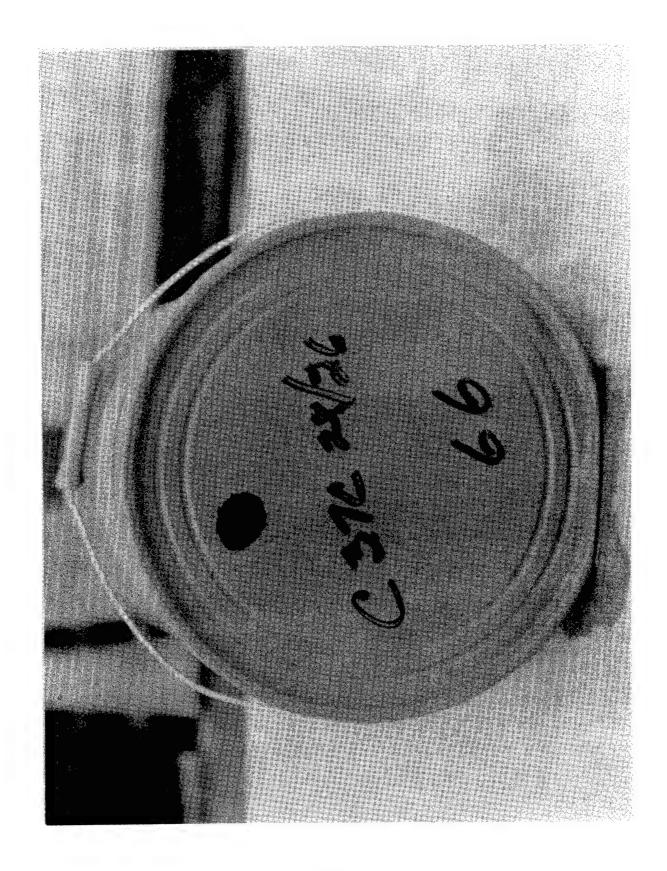
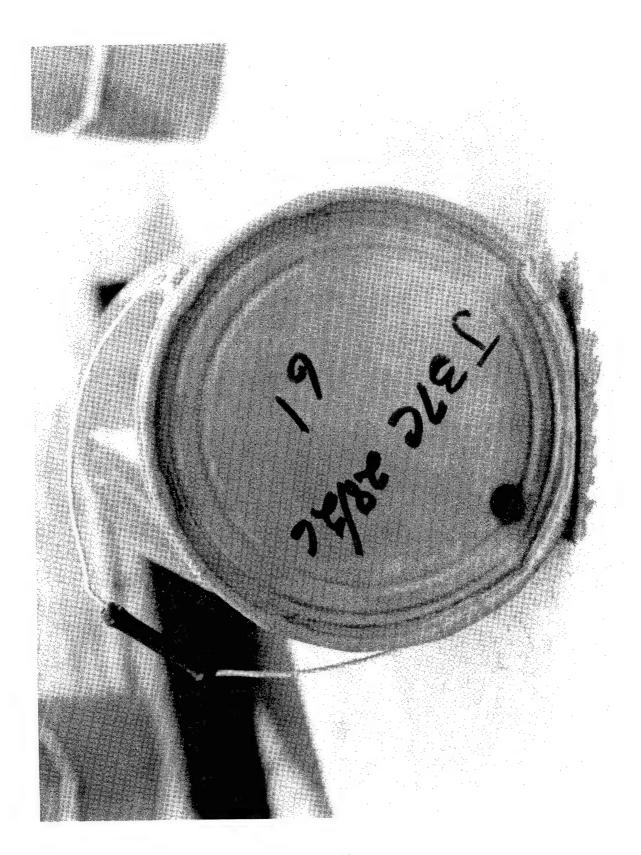
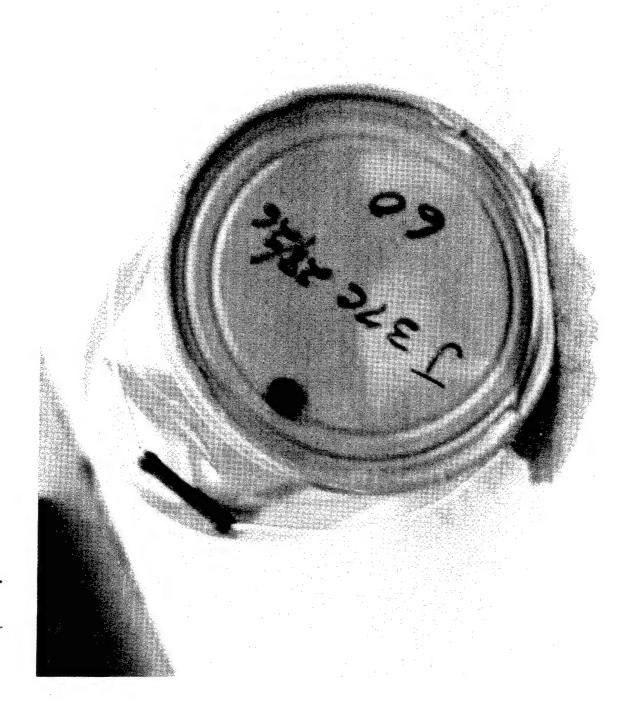
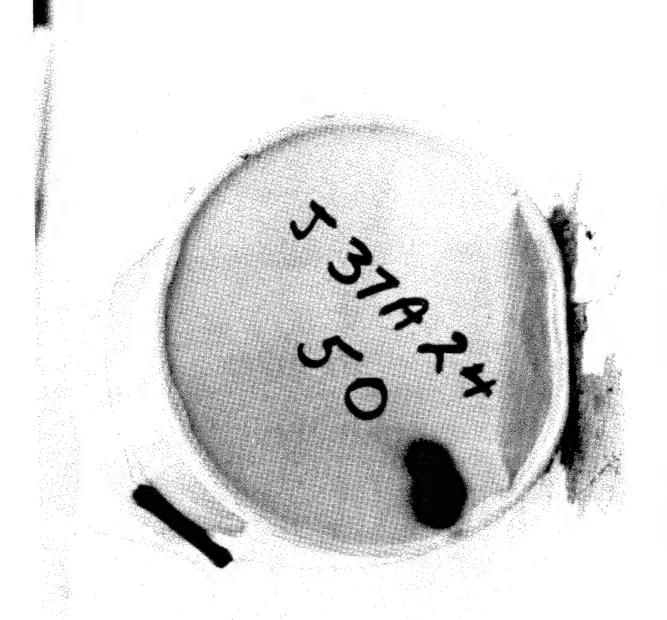
Horizontal Drop Test. The containers were prepared and tested in the same manner using the same height and test equipment as for the Theorems1 drop test, with the exception that the containers were raised as illustrated in Figure 27 and dropped so that the side seam impacted the lead and After drop, the container and pad were examined for spillage. It results reported in Table 4 reveal that seven drums and six pails failed the test. Failures for the drums were noted as leaks at the locking ring joint of Exhibits 12, 15, and 73, and Exhibit 39 leaked at the end of the crush pattern. Exhibit 110 leaked at bottom chime, and Exhibits 142 at 143 leaked at the locking ring joint when lifted by the crane to be druped. The latter two drums (142 and 143) were not dropped. Failures of the pails were noted as leaks at the covers of Exhibits 11, 45, 50, 60, 61, and 66.

Typical failures are illustrated in Figures 28 through 35.

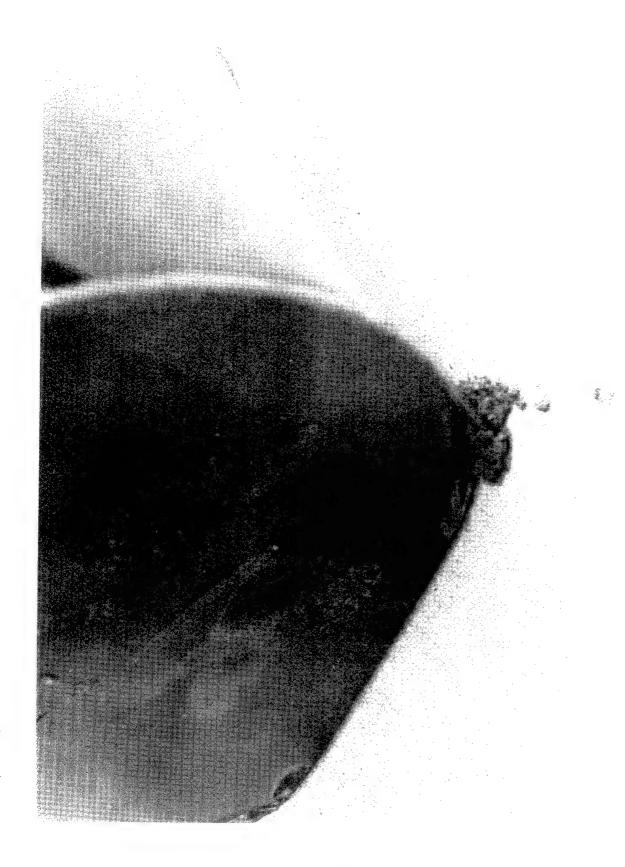
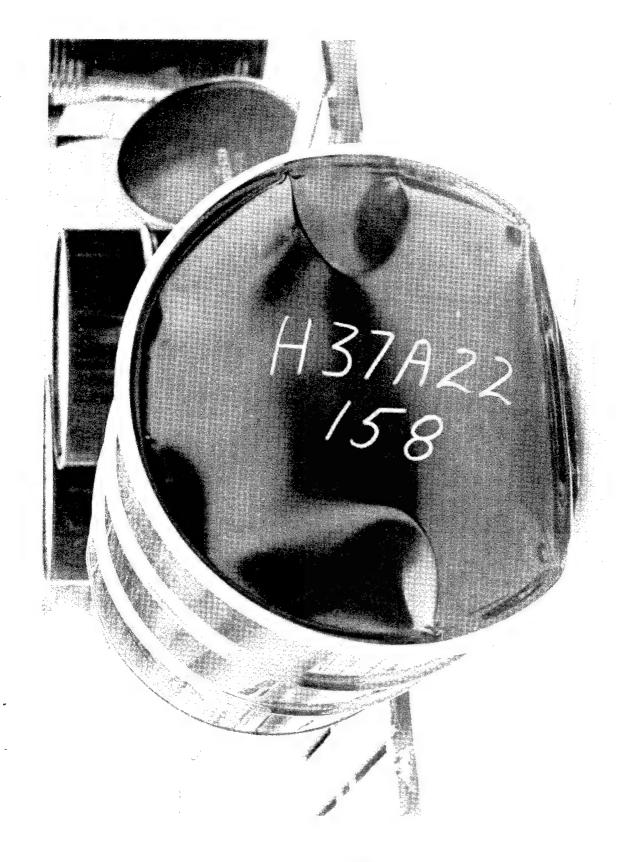
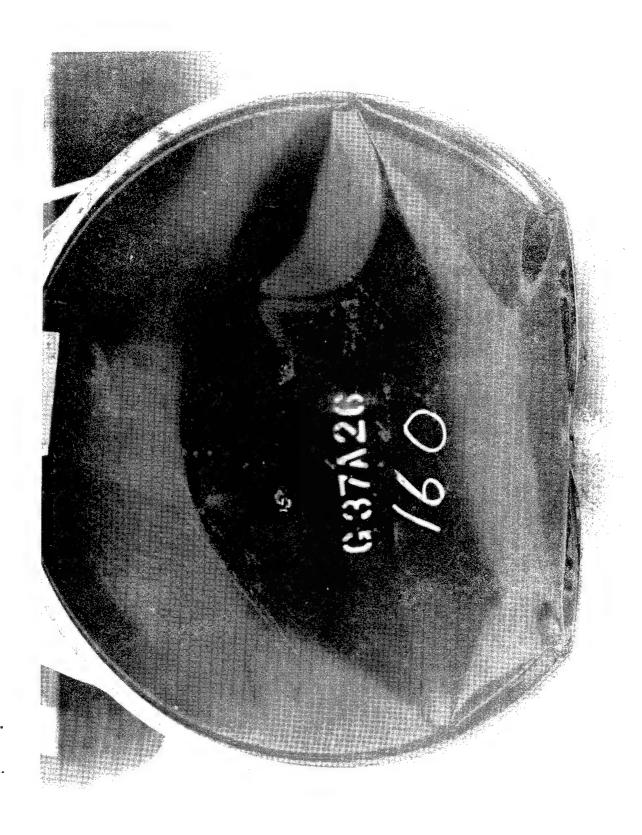
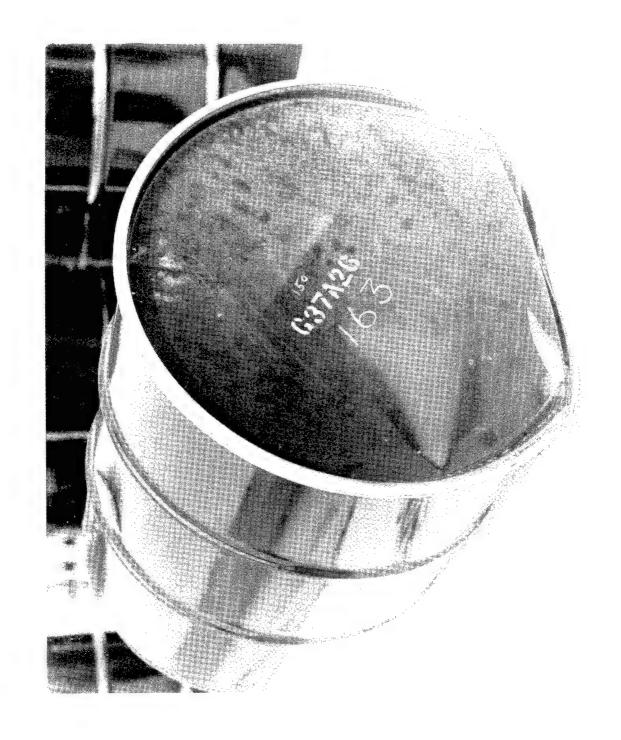
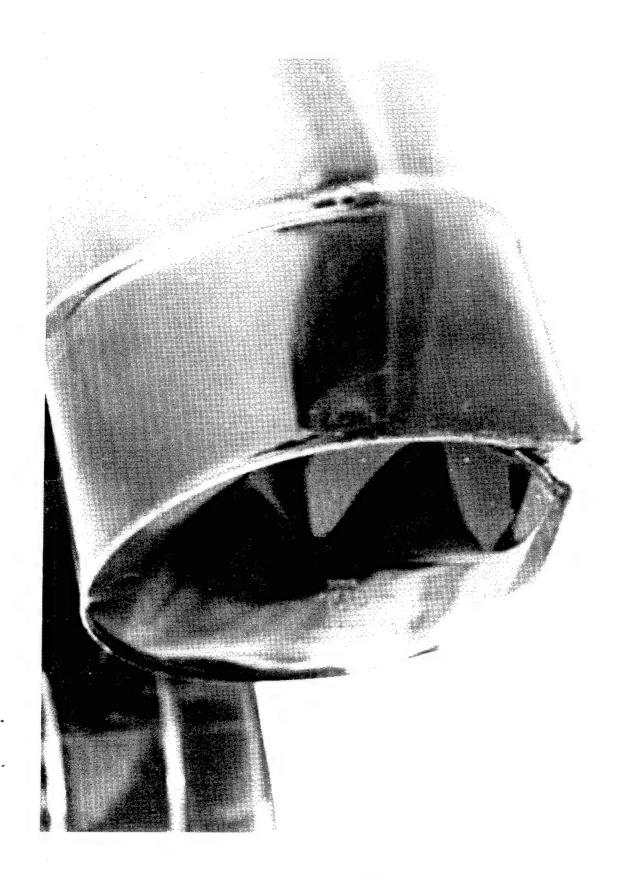
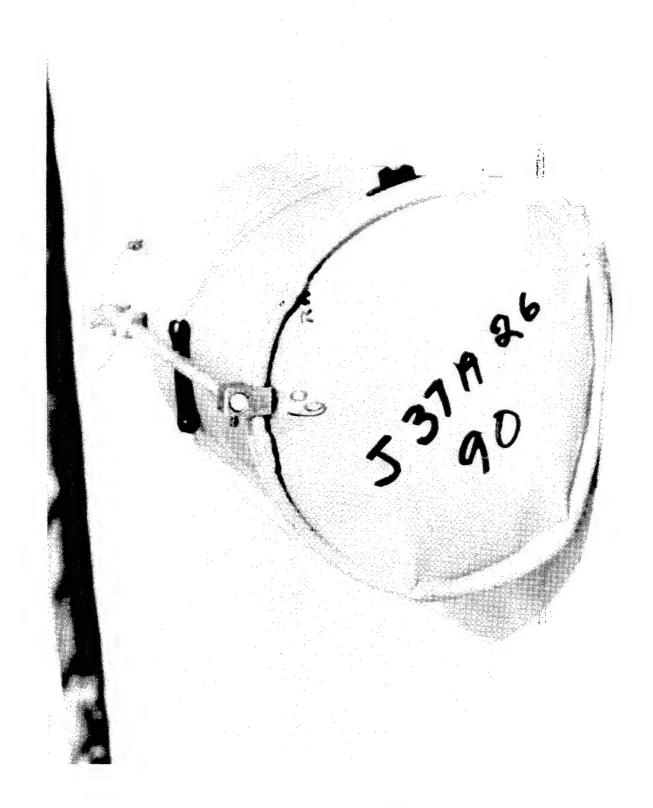
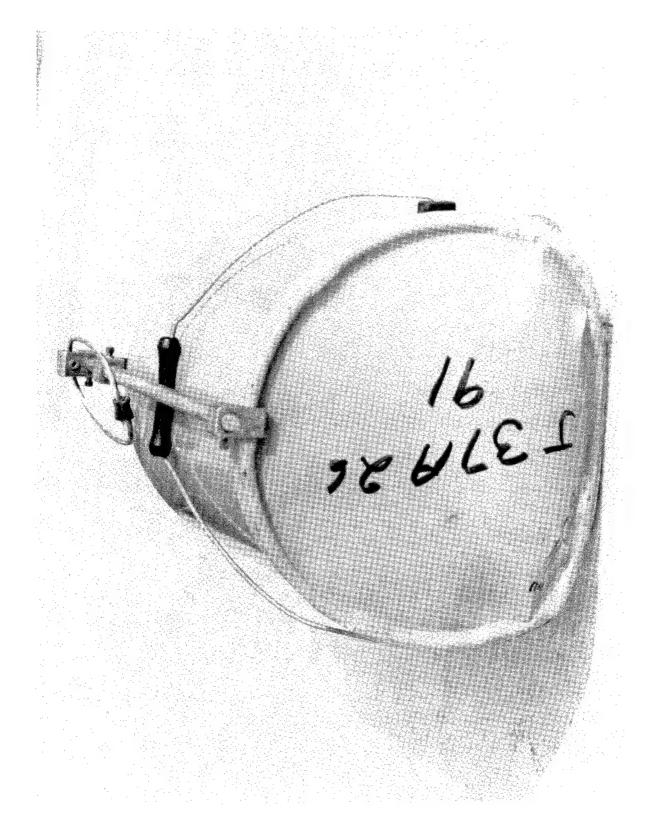
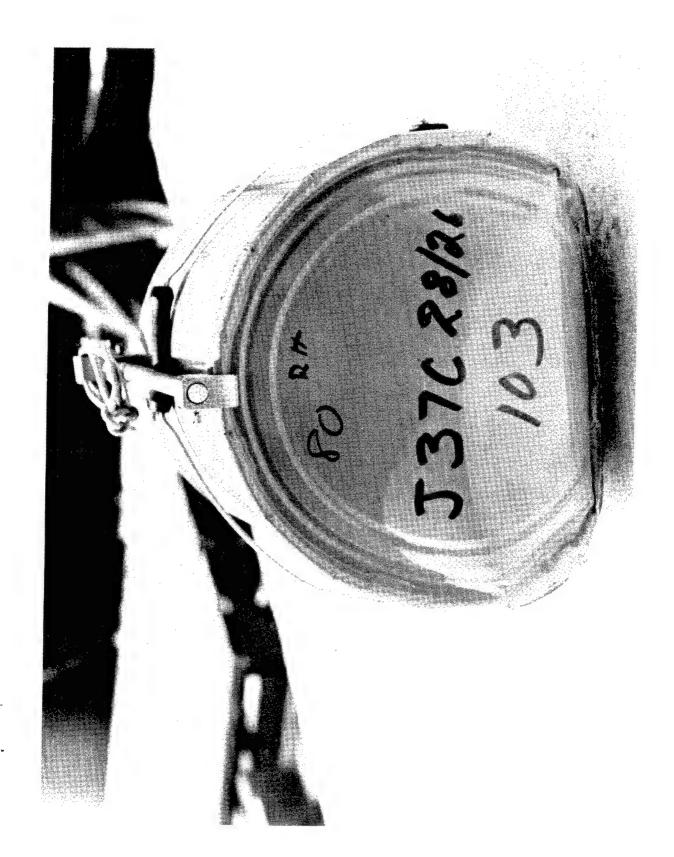
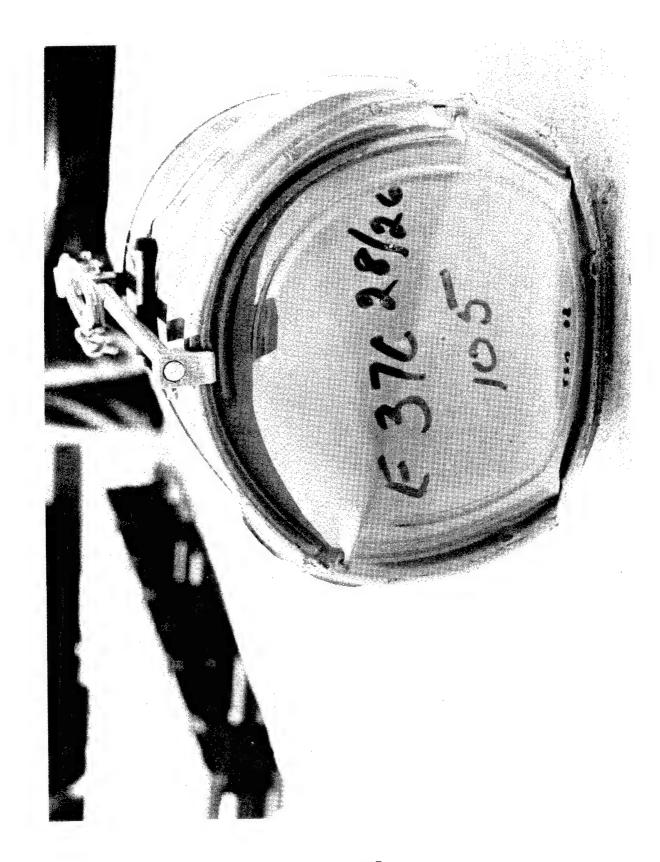
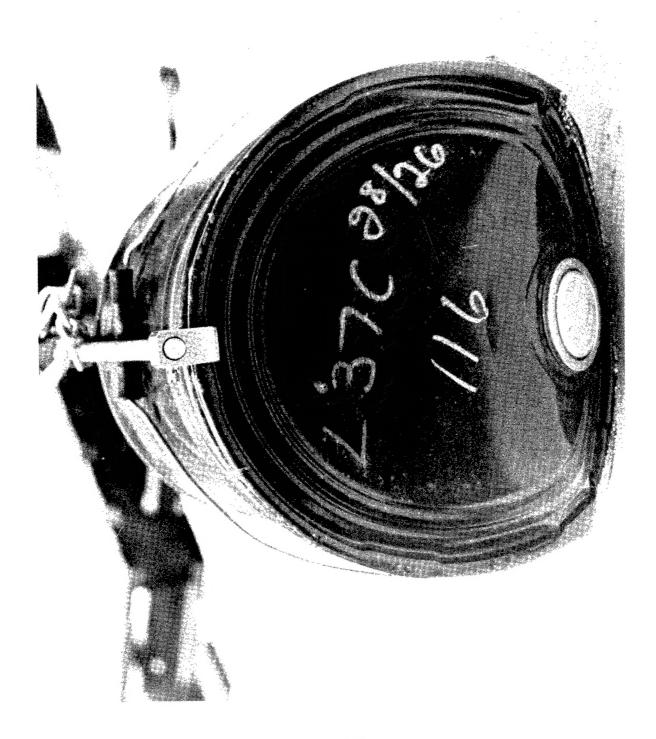
The results reported in Table 4 indicate that seven drums and five pails failed. Drum failures were noted as a split chime at the bottom of the container for Exhibit 71, a leak at the end of the crush pattern for Exhibit 158, and a leak at the ring closure for Exhibits 69, 160, and 163. Metal tore 3 inches at the bottom chime for Exhibit 157 and a leak at the ring closure for Exhibit 69. Failures for the 5 gallon pails were noted as leaks at the end of the crush patterns for Exhibits 90, 91, 103, 105, and 116. The failures are illustrated in Figures 36 through 46.
